# Installation Guide Repair Products CRP

## Repair patch for high-temperature polyethylene coated pipelines

### Pipeline Repair Patch

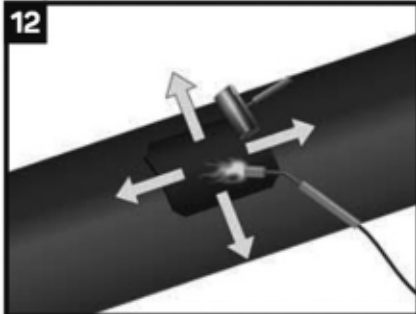
### Repair: Post Heating Repair Patch

Using the roller and propane torch, continue heating and rolling from the middle to each edge. Continue until the adhesive is fully molten and has wet out on all edges.

**CAUTION:** Too much heat in one spot can damage mainline coating. Keep the torch moving at all times.
